LAKE CARMEL DAM

PUTNAM COUNTY, NEW YORK
INVENTORY NO. N.Y. 100

PHASE I INSPECTION REPORT
NATIONAL DAM SAFETY PROGRAM

NEW YORK DISTRICT CORPS OF ENGINEERS

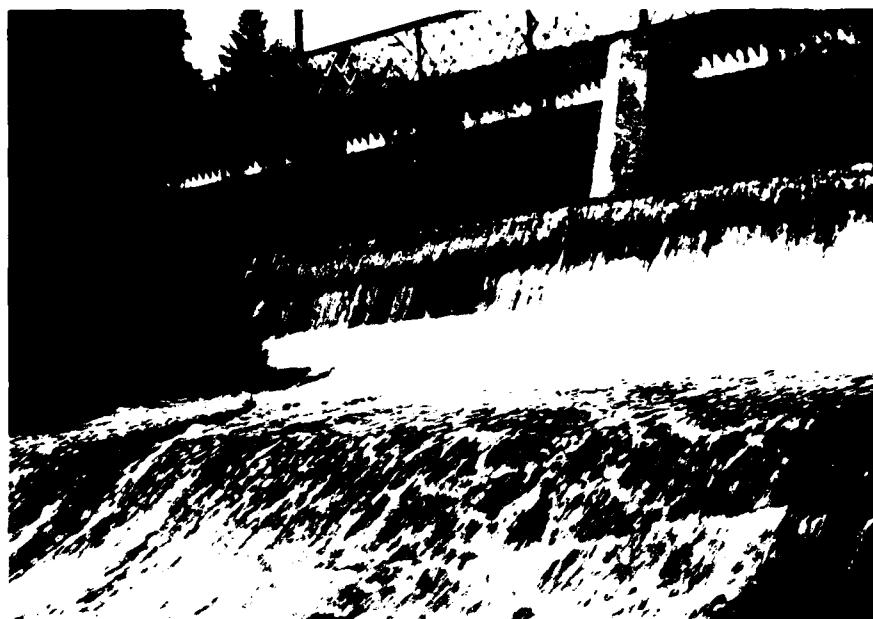
2. VIEW OF SPILLWAY CHUTE AND APRON.

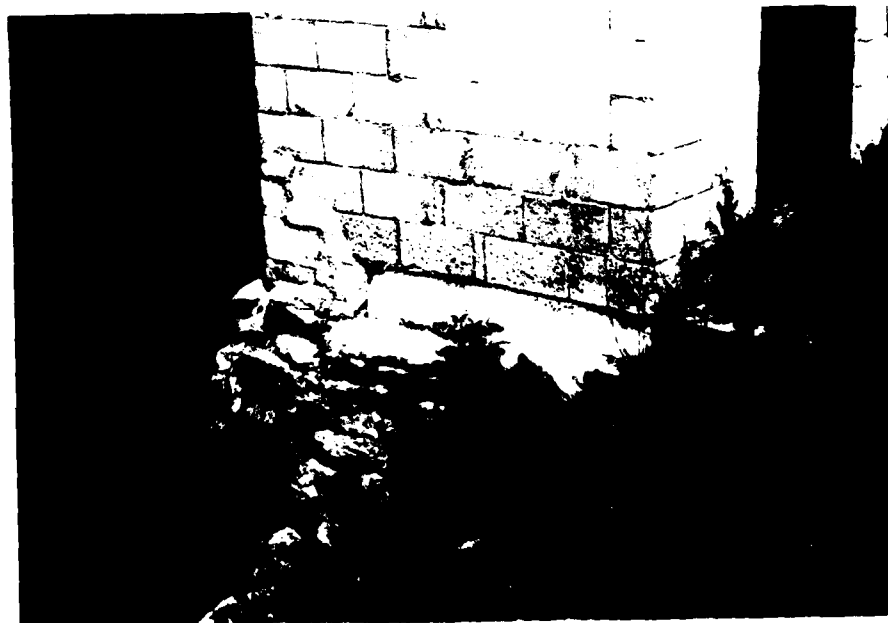
5) The Gatehouse masonry foundation is severely cracked with stones missing (see photographs 8 & 9).

9. LOSS OF GATEHOUSE FOUNDATION ON SOUTHWEST
OF STRUCTURE.

- 7) Foundation walls for the gate house should be reconstructed.
- 8) Removal of small trees (less than 8" diameter), brush and shrubs from embankment slopes and proper backfilling of resulting depressions or holes with subsequent seeding should be performed. Removal of larger trees may be difficult because of the more extensive root networks and therefore is not recommended, however, these trees should be inventoried and monitored for seepage near the root ball.
